Monitoring Morphology and Currents at the Hatteras Breach

Ty V. Wamsley

Kent K. Hathaway

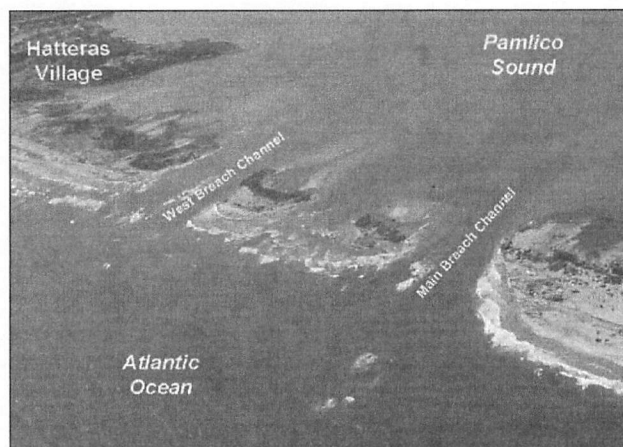
Figure 2. Hatteras breach, 22 September 2003 (USACE Wilmington District photograph).

Wamsley 2003). The Hatteras breach destroyed utility infrastructure and severed North Carolina Highway 12, isolating Hatteras Village from the rest of Hatteras Island. Parking lots and buildings near the breach were also destroyed. Highway 12 is the only transportation route east from the village. Residents were unable to drive to work and home. Businesses at Hatteras Village and on Ocracoke Island experienced loss of tourism revenue because of the restricted access.

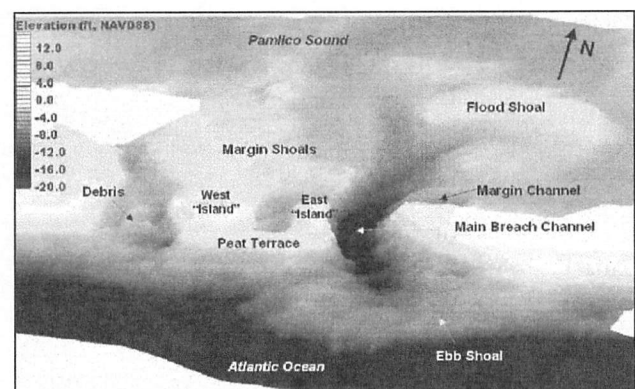
Figure 3. Digital elevation model of Hatteras Breach.

best coverage of the nearshore region just seaward of the breach openings and, combined with the ebb shoal data, provides the most comprehensive data set. Figure 3 is a DEM created for illustrative purposes from Survey 2 data combined with the multi-beam ebb shoal data. Three breach channels, separated by breach islands, are well defined. The breach islands were not washed away because of resistance of peat outcroppings that fronted the islands on the ocean side (Figure 4). The peat acted as an erosion-resistant barrier, retarding the island at this location. The broad peat terrace extended from the eastern most breach island, across the middle breach channel and west breach island (Figure 3).

The flood shoal is readily identifiable in Figure 3. The Survey 1 DEM showed that a flood shoal formed within 2 weeks after the breach opened with the centroid approximately 1,750 ft from Highway 12. The shallowest water over the flood shoal was less than 0.5 ft NAVD88 and had to be surveyed by wading, as depths were too small even for the waverunner system. The second survey showed little growth of the flood shoal. A volumetric analysis indicates that the flood shoal gained on the order of 10,000 cu yd of sand over the 10-day period. A well-defined ebb shoal also formed by 5 October (Figure 3). The ebb shoal extended offshore as far as 1,250 ft from the former location of the highway. Depths over the ebb shoal were 4 to 6 ft NAVD88. Waves were often observed breaking on the ebb shoal.

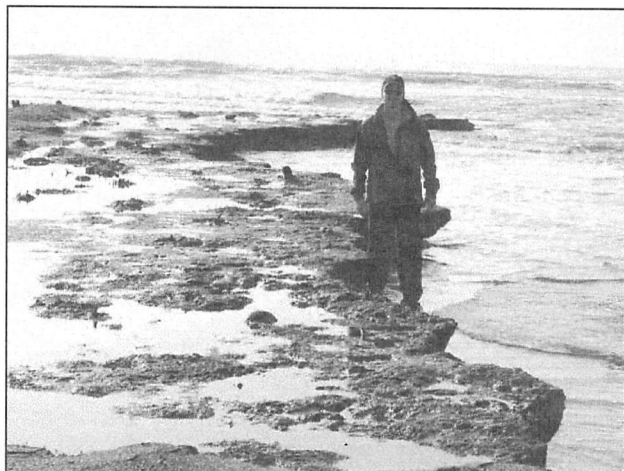
Figure 4. Western edge of peat terrace, looking southeast. The peat extends approximately 1.5 to 2 ft above the adjacent sandy bottom.

The peat terrace restricted flow in the middle breach channel, which was about 225 ft wide. Water flowed through the middle channel and over the peat terrace only at higher tide elevations. The restricted flow resulted in little scour of this channel. Maximum depths in the middle channel were about 5 ft NAVD88 (1988 North American Vertical Datum). The west channel was about 350 ft wide and littered with debris (Figure 5). Pilings from the bridge partially constructed in the 1930s extended across the channel on the ocean side. Large chunks of asphalt and roadbed material were visible at lower tide elevations, particularly on the west side of the channel. Near the center of the channel was a peat outcropping with large chunks of asphalt resting on top. The flow through the west channel was somewhat greater than that of the middle channel. Survey 2 maximum

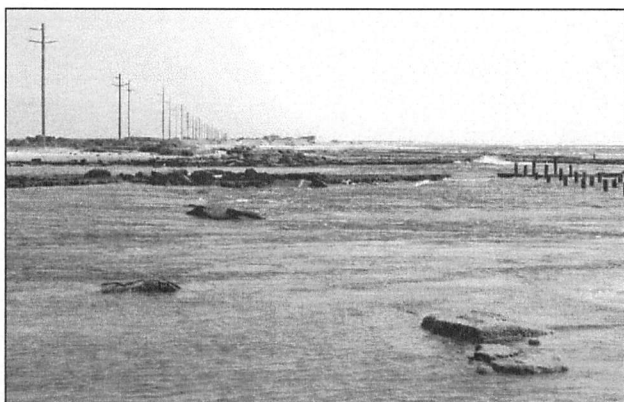
Figure 5. West breach channel, looking east, 5 October 2003. Note the old bridge pilings on the right and the extensive road debris in the channel.

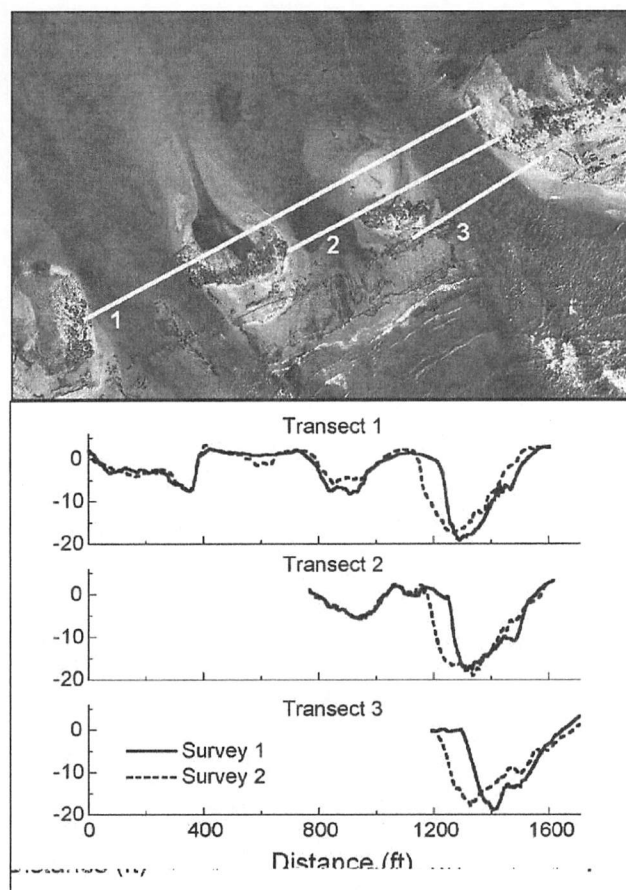
The DEM analysis indicates rapid morphology change. Figure 6 is a comparison plot of breach cross-sections from Surveys 1 and 2. Comparisons are made only where sufficient coverage of the channel was captured by both surveys. Due to debris and wave conditions, the seaward end of the west breach channel was not measured in Survey 1. As Figure 6 shows, there was little change in the west channel, because of the substantial amount of armoring by debris and peat. Flow velocities were significantly weaker than observed in the main channel. The sound end of the

Figure 6. Comparison of Survey 1 and Survey 2 breach channel cross-sections (North Carolina Department of Transportation (NCDOT) photograph).

middle channel shoaled approximately 2.5 ft in the 10 days between surveys. The sediment likely originated at the margin shoals on the sound side and could not be flushed out by flow restricted by the peat terrace. The central and seaward portions of the middle channel did not change between Surveys 1 and 2.

The main breach channel experienced the greatest amount of change. Defining breach width as the distance across the channel between the NAVD88 0-contour (which corresponds to +0.44 ft msl), the breach widened by approximately 125 ft on the ocean side, 65 ft through the middle part of the channel, and 25 ft on the sound side. From the center of the barrier toward the sound, the main channel migrated approximately 20 ft to the west over the 10-day period while on the ocean side the channel migrated over 80 ft to the west. The average channel depths were maintained and maximum channel depths generally increased through the middle part of the channel and decreased on the sound side over the 10-day period. The average cross-sectional area of the breach channel increased from 3,400 to 4,000 sq ft.

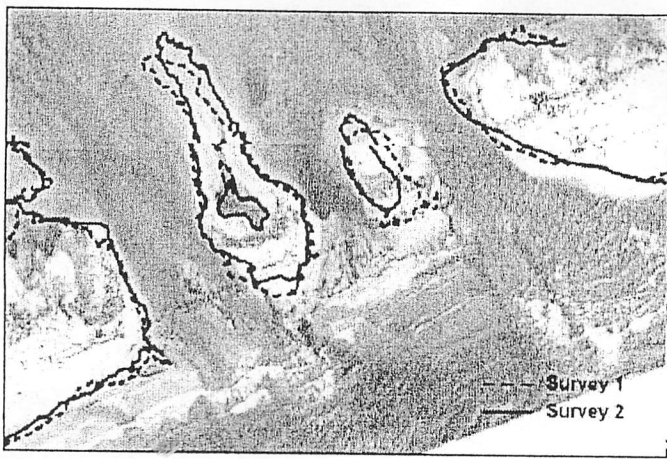
Figure 7. Comparison of the 0-contour (NAVD88). The aerial photograph was taken on 24 September, tide elevation -1.3 ft NAVD88 (NCDOT photograph).

Figure 7 is a comparison of the 0-contour (NAVD88) between Surveys 1 and 2. The recession of both channel banks at the ocean end of the breach is evident. The east bank receded 25 to 45 ft while the west bank moved 40 to 80 ft. On the sound end of the breach channel, the east bank advanced approximately 25 ft, pushing the channel to the west. This end of the channel also continued to widen, however, as the west bank receded about 45 ft.

Figure 7 illustrates the elongation of the margin shoals behind both breach islands. The east island shoal advanced approximately 65 ft. The west island shoal migrated in a

northerly direction and also elongated by approximately 65 ft. The 0-contour on the front side of each island receded. This recession, however, was not from erosion of the peat terrace. The peat terrace elevation was below 0 NAVD88, and the sandy material on top eroded during higher tide elevations.

Figure 7 also shows beach shoreline change within about 500 ft of the breach. On the west side, the beach eroded approximately 35 ft. Sediment supplied by longshore transport
